Inspection Report Minerals Regulatory Program May 14, 2013

Mine Name: Snow White 1 Mine	Permit Number: M/049/0030
Operator Name: Interstate Brick Company	Inspection Date: May 14, 2013
Inspector(s): Lynn Kunzler & April Abate	Time: 2:00 PM
Other Participants: Tom Nicolaysen (Intern)	Mine Status: Active

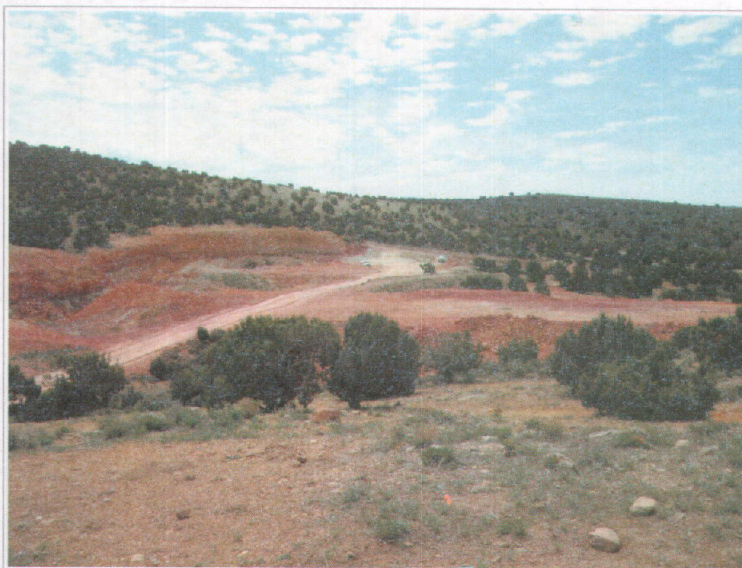
View of head wall and the road to the mine from the north end of the site.

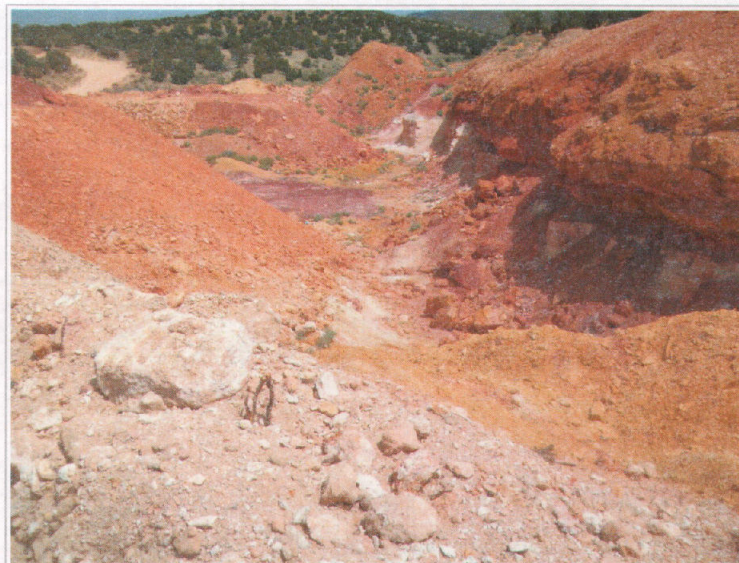
Looking north along the headwall; disturbed areas.

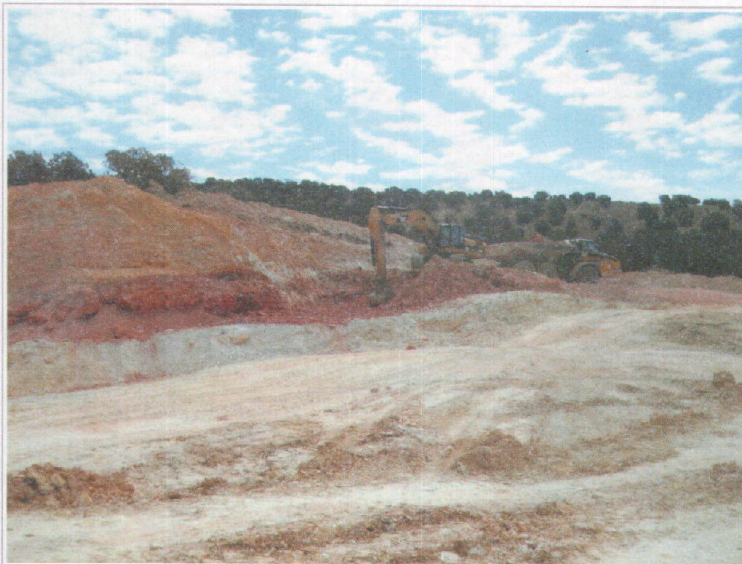
Mining activity was observed during the time of inspection at the south pit. Roger Peck, of Peck Construction was operating the excavator at the mine. Lynn had some question about the size of the disturbance on the south side of the permit area. This area bordered an ephemeral drainage and it appeared to Lynn that they were outside of their permitted boundary. After checking mine maps in the NOI, it was decided that they were not outside their permitted boundary. Additionally, Mr. Peck indicated that the area was to be partially reclaimed over the next week.

Current activity at the site.

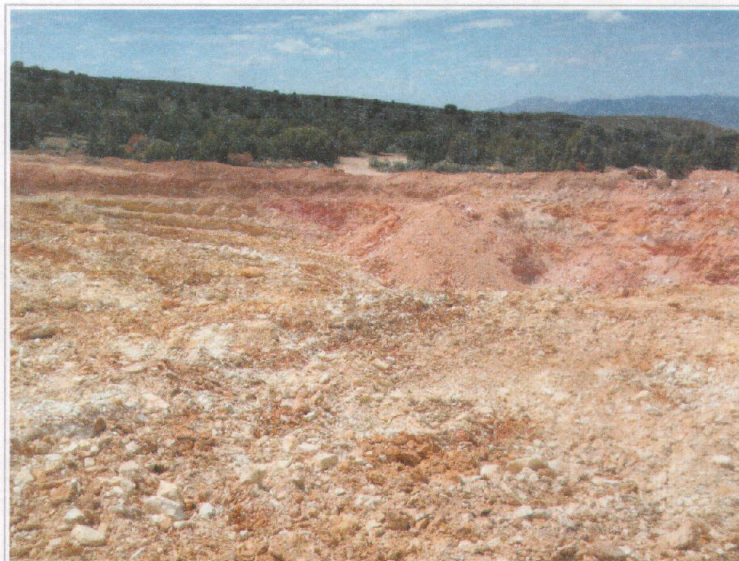
Disturbance at the southwest corner of the site which will be partially reclaimed in a week.

None at this time. Try to revisit the site to check status of reclamation of south pit area.
